OTC-28896-MS

Innovative Subsea Repair Of A Leaking Flexible Joint Using Hybrid Gasket And Composite Material

Ludovic ASSIER - TOTAL E&P; Daniel BYRD - TOTAL E&P NIGERIA; Yves FURMANOWSKI - TOTAL E&P NIGERIA; Kartik GOLECHA - TOTAL E&P NIGERIA; Baptiste BEAUMERT - HUTCHINSON; **Olivier MARIN - 3X ENGINEERING**

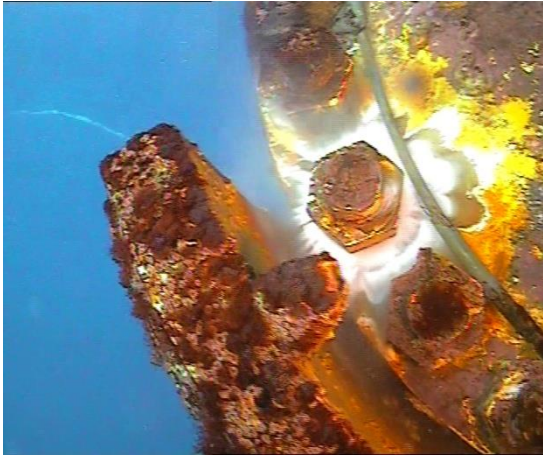
During a diver inspection in April 2016, leaks were reported on two of the water injection flexible joints. These leaks were localized around several of the nuts closing the attached flange of the flexible joints and at the interface between the two parts of the flanged connection:

Fig. 1. Leak observed under a nut

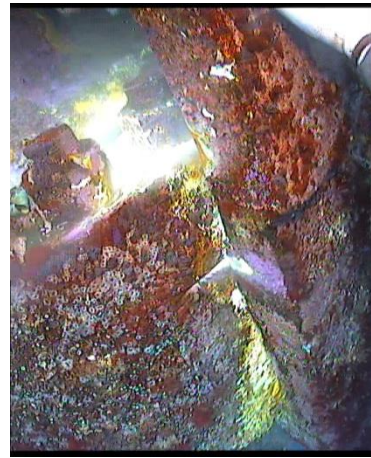
Fig. 2. Leak observed at flange interface

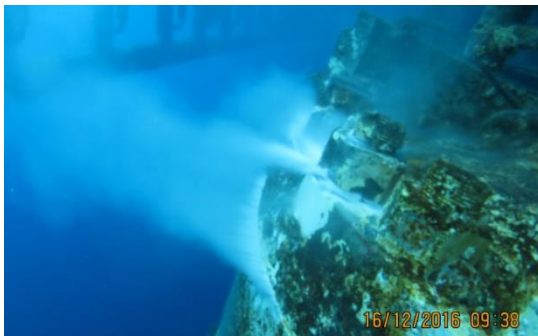
During this second campaign, an escalation of the leak and the damages was observed. Some studs were found eroded; the top flange appeared to be severely damaged below the leaking nuts. At some locations the depth of metal loss reached 1 cm. In addition, the flexible joint receptacle was also starting to suffer damages from the leak.

Fig. 3. Increased leak (2nd campaign)

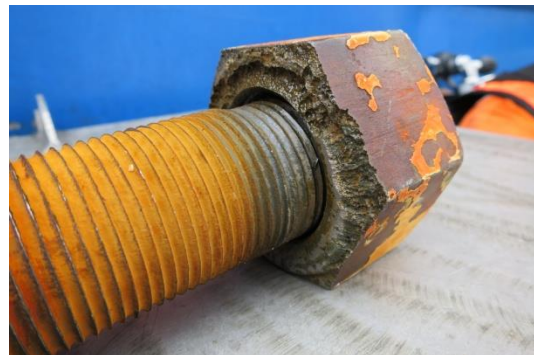
Fig. 4. Damage to studs and nuts (2" diameter)

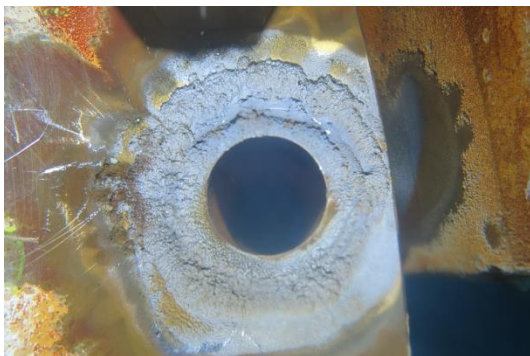
Fig. 5. Damage under leaking nuts (max depth = 1cm)

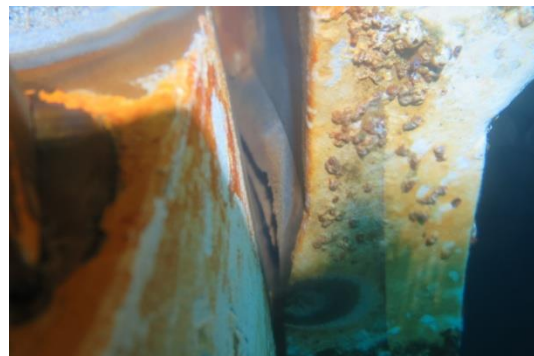
Fig. 6. Damage to the flexible joint receptacle

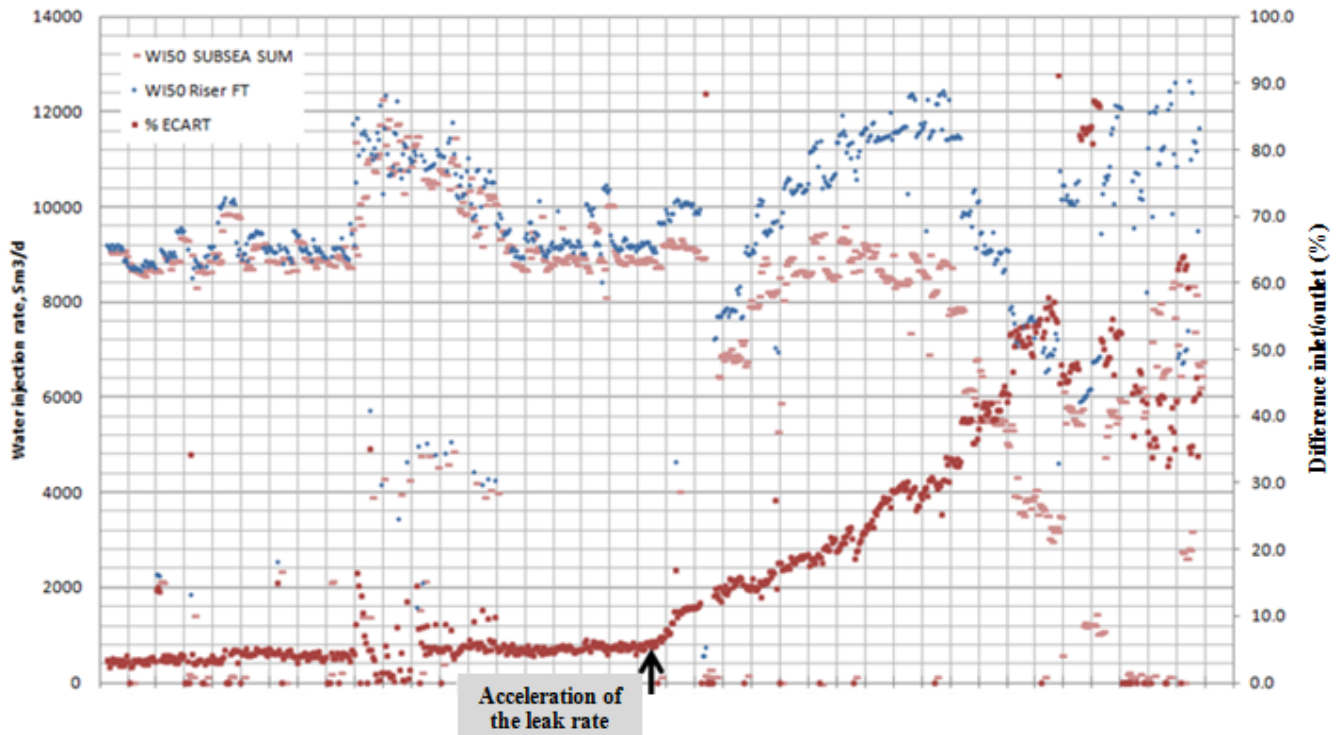
By analysis of the material balance on the water injection system, the acceleration of the leak was clearly noticeable. The

following chart (Fig. 7) provides the records of the water entering the riser (blue dots) and the total water injected in the subsea wells (pink dots). The difference between these two values (Quantity of water entering the riser – Quantity of water injected in the wells) corresponds to the leak rate. This rate is provided as a percentage of the water entering the riser (red dots) in the same chart:

Fig. 7. Material balance on water injection system WI 50

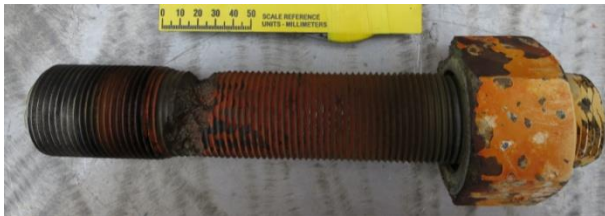
The groove on the attached flange was found damaged by what is believed to be the consequence of cavitation due to the leak. As shown on the below picture, some of the studs were also found damaged by the leak flow. The BX steel gasket was also recovered and inspected - it presented similar damage patterns.

Fig. 22. Damage on a recovered stud (2inch diameter)

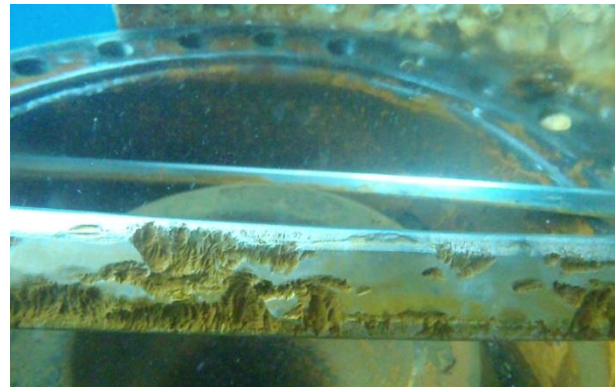
Fig. 23. As-found condition of the BX steel gasket

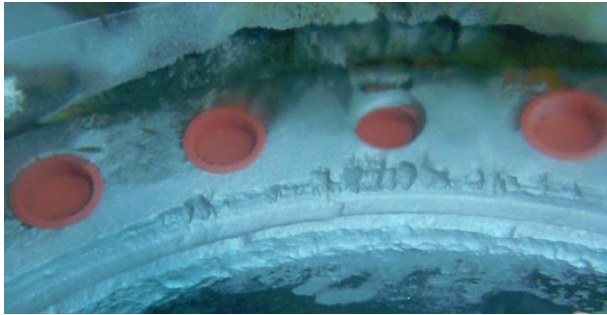
Since only the diver had access to the lower groove, a mould of it was performed subsea using plasticine to assess the level of damage present on the groove and decide on the repair to be put place – as described in the previous section. The extent of damage was so large that the groove had to be re-shaped using composite repair material.

Fig. 24. Example of the groove severe damages on the flexible joint body and receptacle

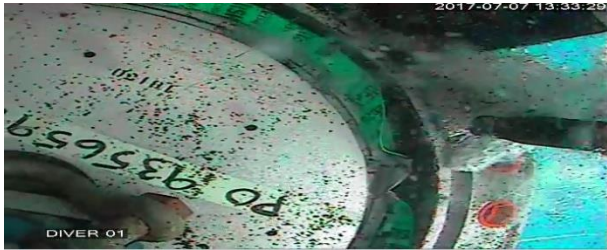
Fig. 25. Subsea Grit blasting of the groove

First, subsea grit blasting was performed using service air available onboard the FPSO. The quality of the surface preparation was controlled onboard the diving vessel on a sample plate. After this surface preparation, an epoxy primer was manually applied by the diver before application of the composite repair material. To achieve the required groove shape, a mould was then installed and maintained in position by studs during the eight hours of curing time.

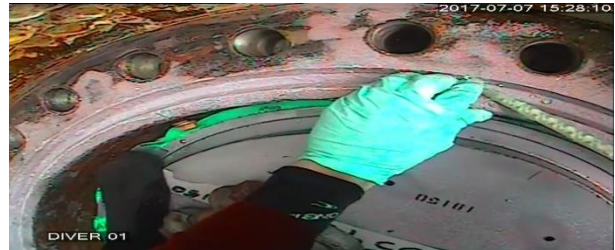
Fig. 26. Epoxy primer application

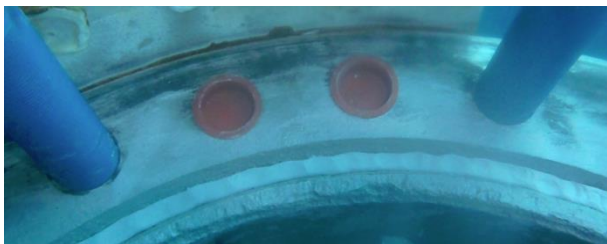
Fig. 27. Application of the composite repair material inside the groove

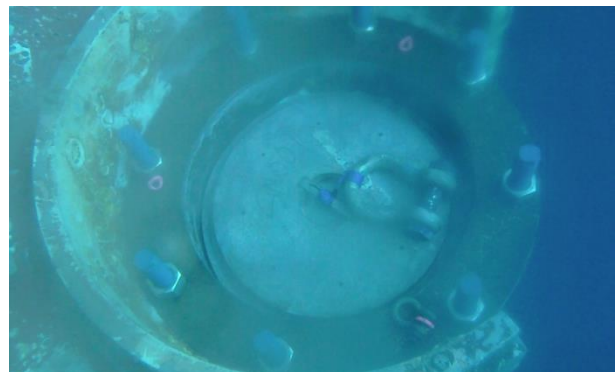
Fig. 28. Mould in place during the curing time

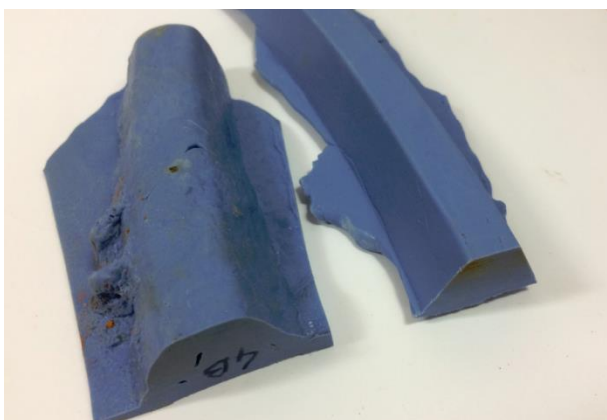
Fig. 29. Plasticine mould of the groove before repair (left) and after repair (right)

It can be seen that with the application of the composite repair material, the geometry of the groove was successfully rebuilt within the original dimension.

The final shape of the groove on the body of the flexible joint was then confirmed by making a new mould using plasticine. The following figure (Fig. 29) gives a comparison of the moulds of the groove before and after repair.

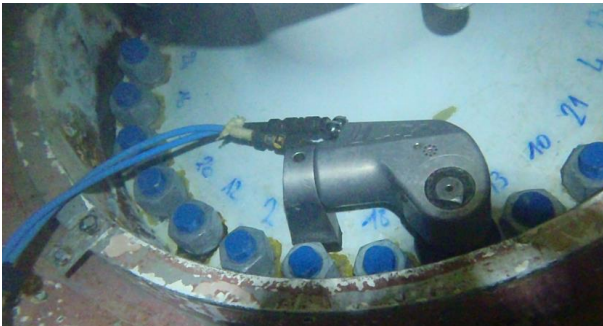
Fig. 30. Torquing tool in position inside the receptacle

At this stage the flexible joint was ready to be re-assembled. The hybrid gasket was then installed, since the composite repair would not withstand the contact pressure from a conventional steel BX gasket. A new attached flange was installed, with a new set of studs and nuts. A hydraulic torque tool was used to fasten the nuts. The subsea torquing of the studs was measured by ultra-sonic measurements. A baseline measurement was initially performed on the studs prior to torquing. Then after each step of the torquing sequence the elongation of the studs was measured and compared to the target value.

The targeted elongation had been previously calibrated by UT measurements on studs tensioned using hydraulic jacks. This initial calibration is mandatory because the speed of sound in the studs varies with the tension of the studs. Without this correction on the speed of the UT signal, all the studs would have been undertensioned.
