Under

Wraps

Jean-Francois Ribet, 3X Engineering, Monaco, recounts the repair of subsea caissons at a North Sea platform, using composite wrapping.

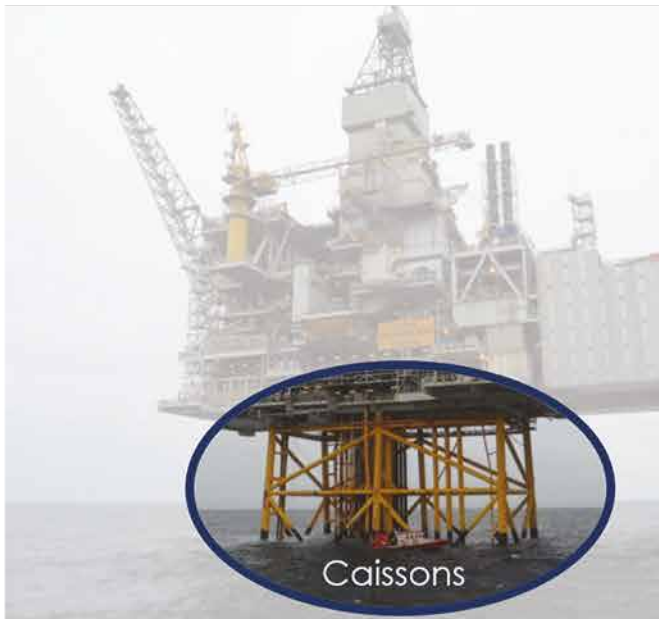
3X Engineering, alongside its partner in the North Sea, was asked to solve corrosion and leak problems on the subsea caissons of an offshore platform. The caissons were experiencing corrosion that had created holes with diameters of up to 300 mm.

Figure 1. View of the subsea caissons.

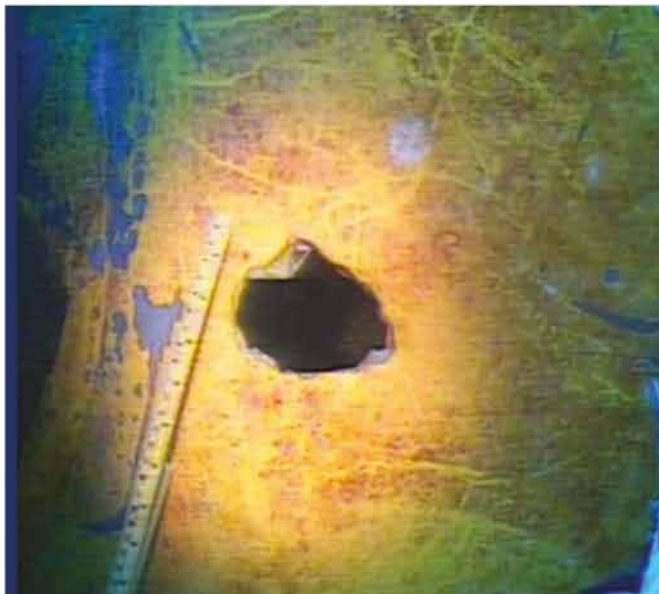
Figure 2. Measurement of the defects.

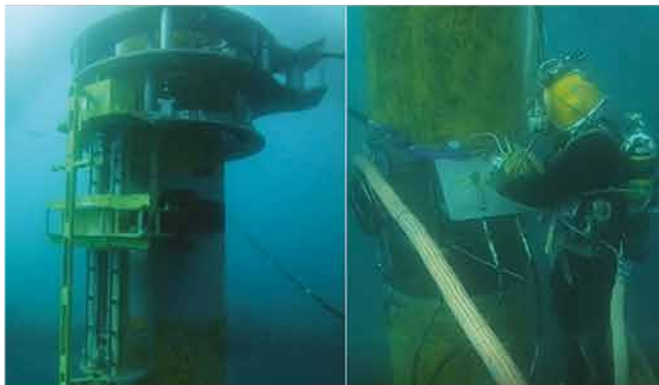
Figure 3. Tape wrapping machine monitored by diver.

- ▶ Clean the caissons and sandblast them in order to achieve at least a SA2.5 surface preparation and a minimum roughness of 60 µm.
- ▶ Cover the hole with plate and a specific subsea filler developed by the company.
- ▶ Cover all of the sandblasted surface with a subsea primer.
- ▶ Prepare the composite tape on the platform using the company's BOBiPREG®, an impregnation tool.
- ▶ Wrap the composite tape on the caisson using a hydraulic-driven wrapping machine monitored by the divers.

Despite delays due to bad weather, the application of the composite wrapping was successful. Depending on the defect, the repair length varied between 780 mm to 2340 mm for a total composite wrapping length of 6800 mm. The wrappings were made both on a straight line and on tee.
