OTC-28896-MS

Innovative Subsea Repair Of A Leaking Flexible Joint Using Hybrid Gasket And Composite Material

Ludovic ASSIER - TOTAL E&P; Daniel BYRD - TOTAL E&P NIGERIA; Yves FURMANOWSKI - TOTAL E&P NIGERIA; Kartik GOLECHA - TOTAL E&P NIGERIA; Baptiste BEAUMERT - HUTCHINSON; **Olivier MARIN - 3X ENGINEERING**

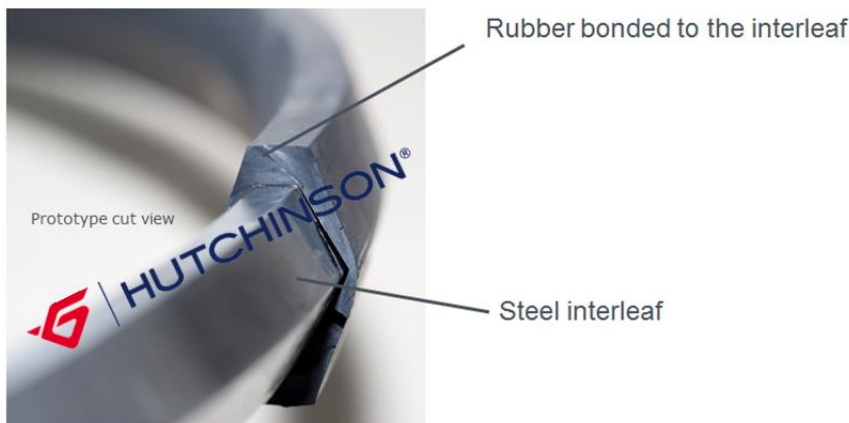
Fig. 8. Cut view of the hybrid gasket

Total contracted Hutchinson (also known as Techlam) to develop and supply a custom engineered and fabricated rubber gasket to repair the leak in only a few weeks timeframe. The challenge was linked to the very tight schedule to develop and fabricate a gasket which had to be installed subsea and able to accommodate small damages potentially present in the gasket groove. It should be noted that it was not possible to precisely determine the exact nature of the defects in the groove before opening the flexible joint. The design of the gasket had to be robust enough to comply with various types of damages (e.g. pitting, scratches, extended damage...). Knowing this requirement, Hutchinson decided to propose a rubber gasket solution, an example of which can be seen in Fig. 8.

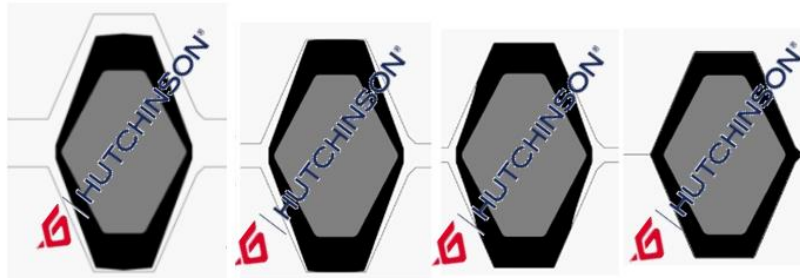
the groove could result in excessively high pressure – due to incompressibility of the water. The gasket would not be able to withstand such pressure and would be damaged. In light of this concern, the solution chosen by Hutchinson was to design a specific gasket profile that would expel all the water out of the groove progressively with the deformation of the rubber. As shown on Fig. 9 below, the first contact occurs in the base of the groove and as the flange is tightened the rubber is progressively deformed until it completely fills the entire free volume, thus preventing any water from remaining trapped.

Fig. 9. Progressive deformation of the hybrid gasket

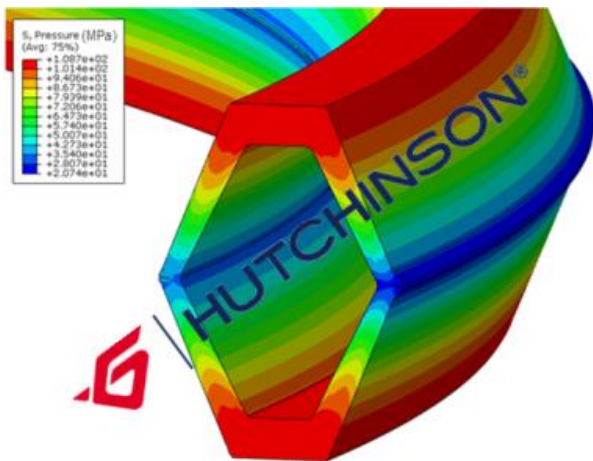
The shape of the gasket is driven by the need to avoid trapped water in the groove; the design focuses on the primary functionality of the gasket: ensure the sealing of the flange assembly. Two points had to be considered. The first point is to keep a contact pressure superior to the working pressure between the metallic groove and the gasket. In this case, the design criterion was a contact pressure of 50 MPa (twice the service pressure). The second point was to anticipate the stress relaxation phenomenon of the rubber material. The only way to pass these constraints was to increase the pressure inside the rubber and to choose a rubber specifically developed for applications subject to stress relaxation. The solution for this consists of including a metallic part (interleaf) inside the gasket. The profile of the interleaf was specifically designed to drive the deformation of the rubber inside the groove and to maintain a high contact pressure in the base of the groove after completion of the installation. It can be seen in Fig. 10, that the top and bottom rubber faces of the gasket are highly compressed over a large area, with a contact pressure well above the criteria. Based on this the stress relaxation phenomena was virtually eliminated, and the sealing of the assembly is guaranteed.

Fig. 10. Results of Finite Element Analysis: compression stress in the rubber

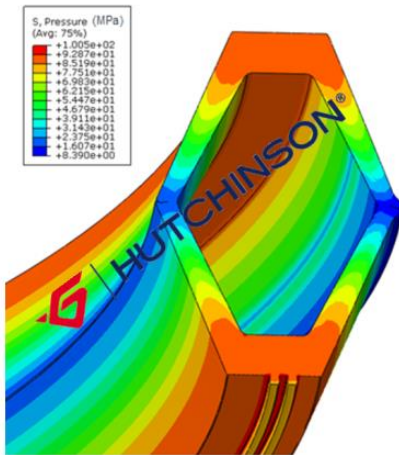
Finally, the last functional requirement to consider was the capacity of the gasket to compensate for unknown groove defects which may be present. Several tests of defect simulation were performed to demonstrate the gasket design robustness. One of the most representative tests is illustrated on the figure below (Fig. 11). A double groove with a square profile of 1 mm x 1 mm has been introduced into the Finite Elements model in the groove base. It is the worst location possible for a defect because this area is the main contact area for sealing. As the model is axisymmetric, the defect has been propagated around the entire groove. It can be seen that even with this type of defect present the rubber still filled entirely the groove and maintains a sufficient level of contact pressure without damaging the rubber.

Fig. 11. Results of Finite Element Analysis: Impact of groove damages (1mm x 1mm)

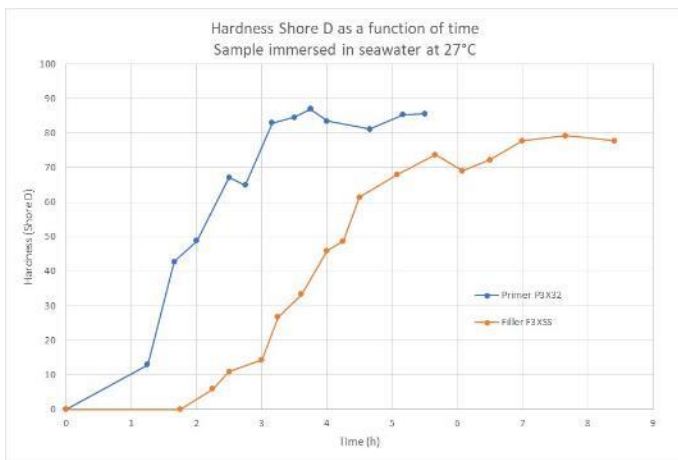
Fig. 12. Hardness (Shore D) evolution as function of time for P3X32 and F3XSS.

From the previous figure (Fig. 12) and considering hardness properties, it can be noticed that the primer reacts faster than the filler. Indeed, the primer reaches maximum hardness after approximately 3 hours, while the filler needs about 7 hours to reach its maximum at 27°C. It can also be noticed that the filler can be modelled during more than 1 hour after mixing. This time was considered sufficient for the divers to apply the filler in the flange groove.

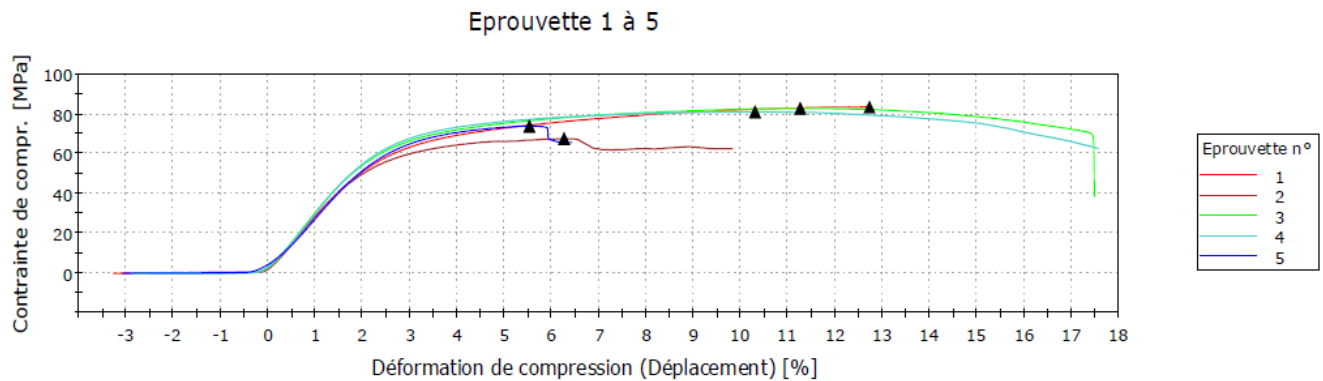
This test was carried out on fully cured filler materials (after 7 days at 27°C). This material has to withstand the compression of the hybrid gasket after flexible joint re-assembly. Fig. 20 provides the results of the compression tests, and it can be seen that the compressive stress is about 75 MPa and compressive modulus is 2600 MPa.

Fig. 20. Compression tests on F3XSS.
