Pigging Industry News

the newsletter of the Pigging Products & Services Association

3X Engineering repairs oil pipelines in The Netherlands

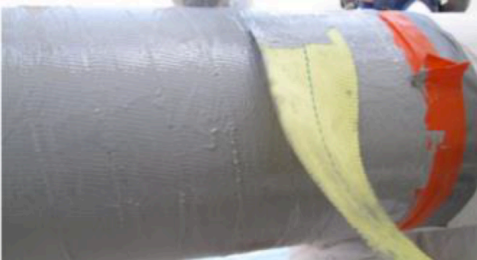
Wrapping in progress ●

Before starting the composite reinforcement, 3X technicians first recognized and delimited the repair areas with adhesive tape. Surface preparation was completed with grit blasting to get a good surface roughness and ensure the bonding between the steel pipes and the composite. The surface was then cleaned using acetone and hygrometric conditions were checked before wrapping procedure.

- F3X8 filler application on each defect to give back the initial shape to the pipes.
- Wrapping process covering the delimited areas was completed using Kevlar® tape impregnated with R3XHT+ resin (4 layers for each defect but with a specific repair length in accordance to defect characteristics —> 260mm repair length for both 10” line defects, 457mm and 1060mm for the defects on 12” line).
- Reference plate for traceability purpose was positioned on each repair.
